Manhole Inspection Summary

Manhole # S37U1_042MH

Record Plat: **37U1** Node: **042** Status: **New Manhole (Not in GIS)** Insp Date: **4/8/09 12:00 AM**

Location Address: **104 chesapeake ave**

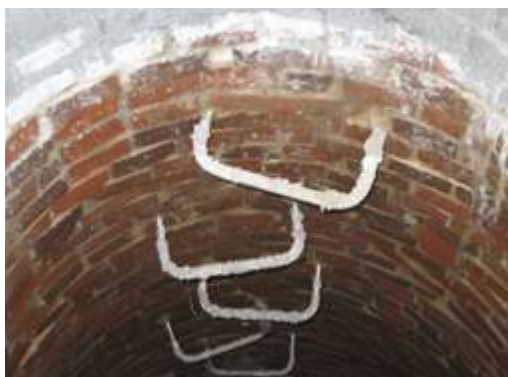
Steps Count: **6** Missing: **0** ☐ Corroded

steps

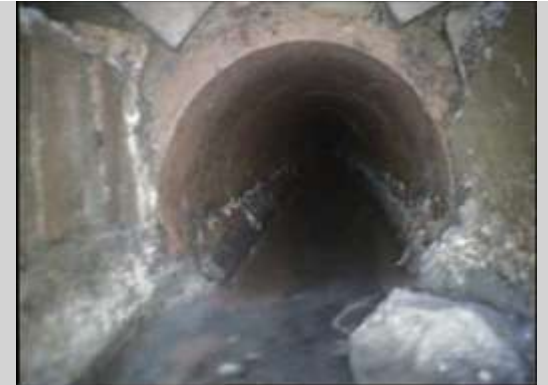
12 O'Clock Outflow

10 in. Circular Gravity Sewer
Pipe Out @ 12 O'Clock

Pipe Height: **9.6** (in.) Rod and Bar (Angled)
Pipe Material: **Clay** ☐ Pipe Lined
Invert Depth: **11.30** (ft.) Flow Characteristics: **Slow**
Deposits: ☒ None ☐ Mud ☐ Sludge ☐ Debris ☐ Grease
Silt Depth: (in.) Deposits Extent:
Infiltration: **None** Pipe Seal Cond: **Sound**

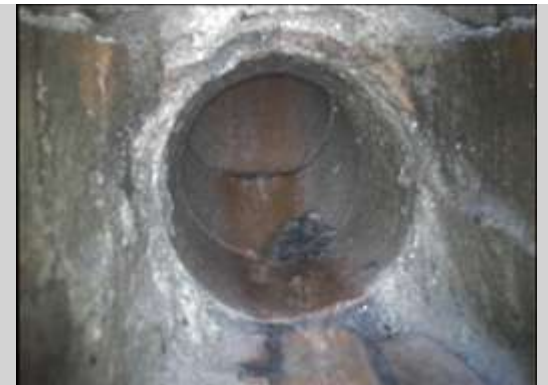
6 O'Clock Inflow

10 in. Circular Gravity Sewer
Pipe In @ 6 O'Clock

Pipe Height: **9.6** (in.) Rod and Bar (Angled)
Pipe Material: **Clay** ☐ Pipe Lined
Invert Depth: **8.10** (ft.) Flow Characteristics: **Slow**
Deposits: ☒ None ☐ Mud ☐ Sludge ☐ Debris ☐ Grease
Silt Depth: (in.) Deposits Extent:
Infiltration: **None** Pipe Seal Cond: **Sound**

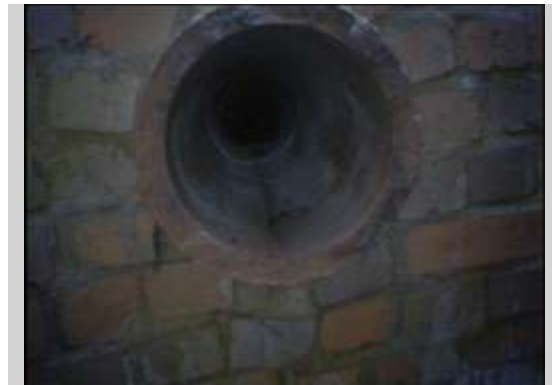
Drop In @ 6 O'Clock

Drop: **Outside** Rod and Bar
Angled: **Yes** Reading: **10.30** (ft.)
Inv Depth: **11.30** (ft.)
Drop Condition: **Open**
